# TECHNICAL BULLETIN

No.4  
September 2000

**Case Study:**  
**Amble Greene, District of Surrey, BC**  
**alternative stormwater management systems**

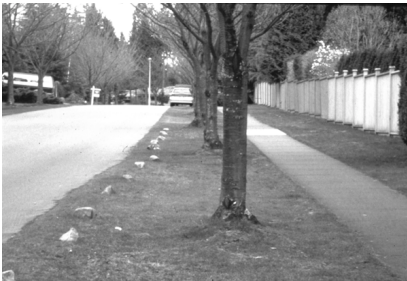
*Figure 4-1 - Streets were edged with a grassy shoulder enabling infiltration capacity at the roadside, an essential aspect of the overall stormwater system.*

To address these stormwater related issues, some municipalities in the Fraser Valley began using innovative stormwater infiltration systems for certain new developments. Designed in 1979, Ambleside Greene was the largest of these developments. The infiltration system in Amble Greene (a development within the larger Ambleside site) is made up of a combination of grass swales and French drains. One small section of Amble Greene is connected to a traditional storm drain system; most of the site is not. The infiltration system is designed to allow continuous and ubiquitous infiltration of stormwater. For enhanced infiltration, the project design calls for a simple street section without a conventional “curbed” road system, as shown in Figure 4-1 and 4-4.

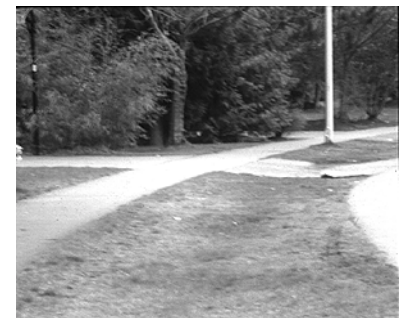
Figure 4-6 - Driveways crossing swales and french drains inhibit the system and allow for the accumulation of standing water.

2) Driveways were designed to cross swales and French drains. The driveway crossings at Amble Greene, as indicated in Figure 4-6, inhibit the system and allow for the accumulation of standing water. Additionally the swales are unpronounced and allow little surface hydraulic movement on a site that is extremely flat, resulting, again, in the accumulation of standing water. It could be argued that the use of design standards such as swales and French drains requires additional standards, such as lanes with rear access to garages in order to create an efficient and functionally sound system.
